# Aptech Updates

August 2005

Aptech Engineering Services, Inc.

Volume 11, Issue 1

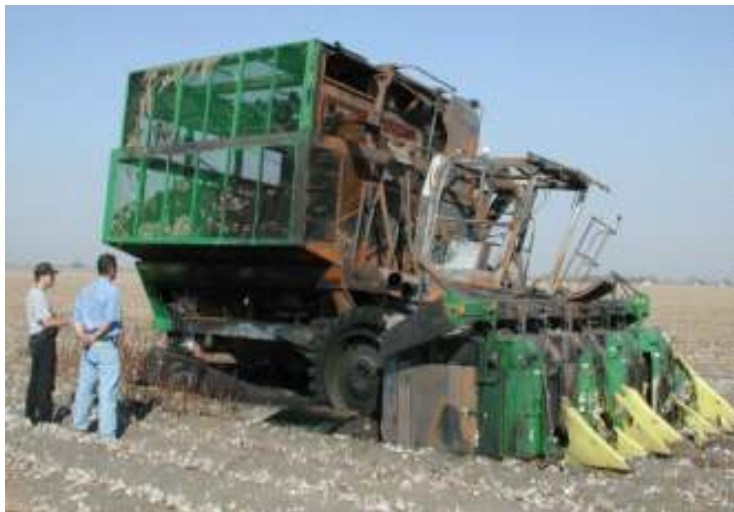
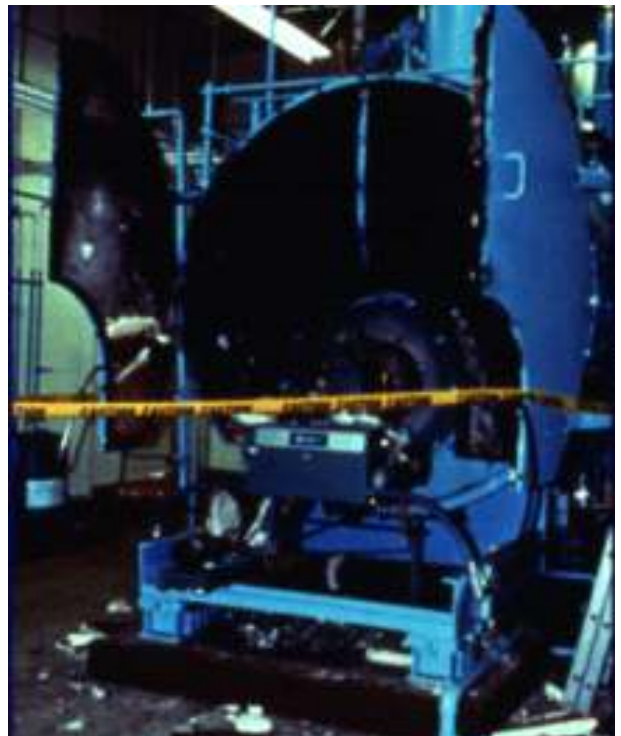
**Agricultural** We are investigating a fire in a **cotton-harvesting machine**. Most cotton picker fires occur in the collection basket on top of the machine, after the pneumatically airborne lint is ignited by a spark from a rock or an old horseshoe. In our case, the fire was in the diesel engine. It was preceded by unusual maintenance activity. Also in the area of agriculture, we investigated a fire in a gas-fired conveyor machine that **dehydrates citrus peel**. The dried peel is used as a cooking spice. One of the gas burners ignited fragments of the dried product that had fallen down into the vitiated air plenum. This fire spread upward into the conveyors and eventually involved the entire plant. Fortunately, the machine itself was stainless steel and survived the fire pretty much intact.
